building inspection service, inc.

CONFIDENTIAL INSPECTION REPORT

Apartment Address

Hoboken, New Jersey

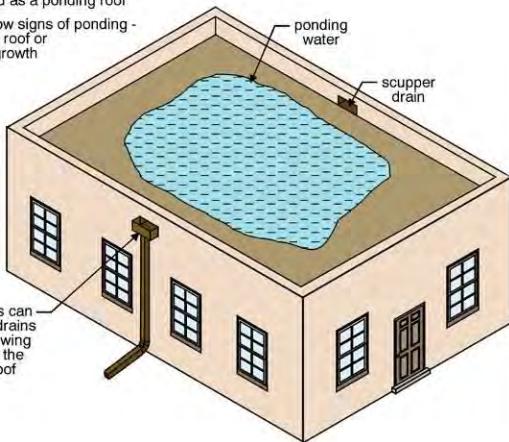
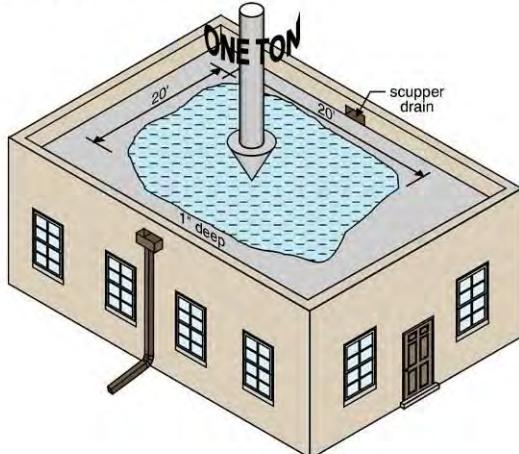
Ponding on flat roofs

Ponding water was noted on the rear left side. This condition is the result of insufficient slope to the roof drains, clogged roof drains, building settlement, structural movement of the roofing material, failure of the insulation board, or a failure of the roof sheathing. Any water remaining on a roof for more than 48 hours should be considered as ponding water. Repairs to eliminate the ponding of water will be required to prevent leaks from occurring. Draining of the ponding water may be necessary to determine the cause for this condition. See illustrations below.

any roof that still has water on it after 48 hours is defined as a ponding roof
a dry roof may show signs of ponding -
dirty circles on the roof or
algae/vegetation growth

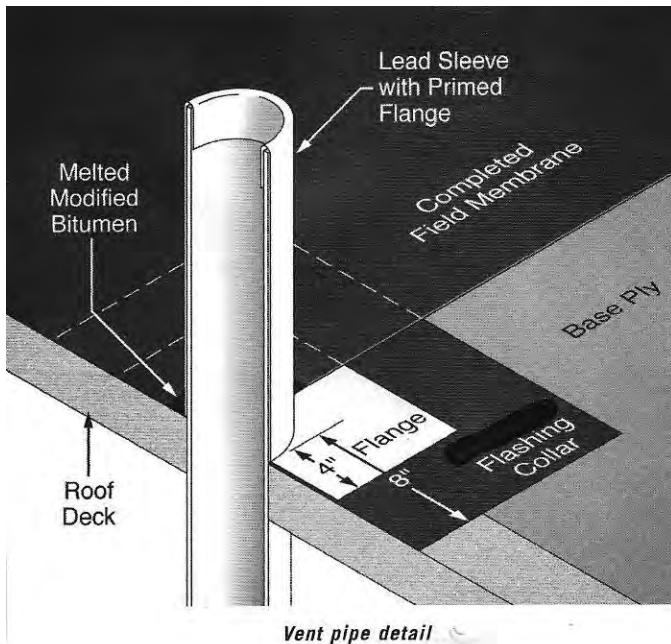
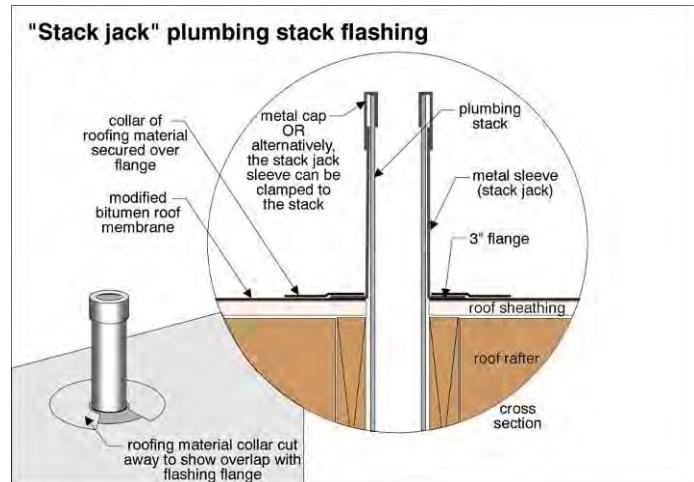
Vent pipe detail

Flashing was lifted, absent and inadequately sealed around the chimney and sewer vent pipes. See photo #'s 14 – 16, 18, 21, 22 & 35 – 39. The installation of flashing will be required to prevent leaks from occurring. See illustrations below.

The seams of all sheet metal vent pipes should also be sealed to prevent water entry when snow is on the roof. Flexible boots should be installed around the base of all sewer, heating and sheet metal pipes and sealed to these pipes with a hose clamp. This type of installation permits movement but prevents water leakage. Repairs are recommended to restore this item to its fully functional condition and to prevent further deterioration from occurring.

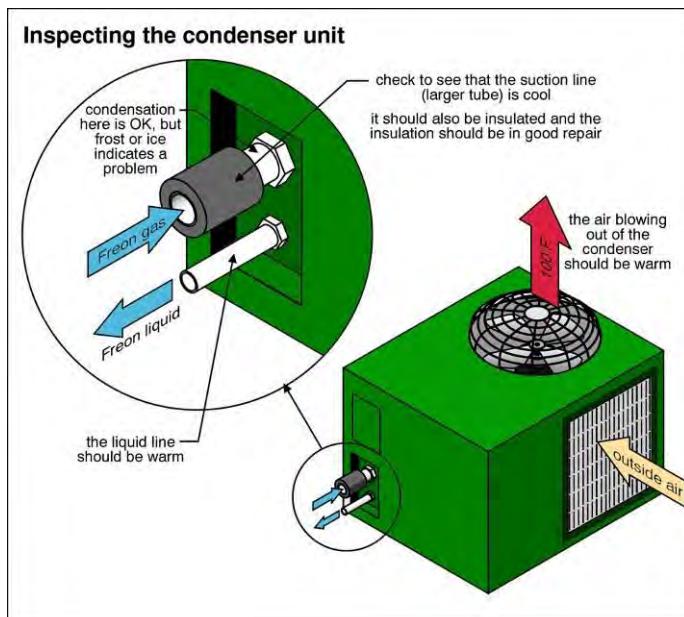
The insulation on the freon suction line, leading to the condensing unit, was damaged and or missing. See photo # 31. The suction line gets cold and should be completely covered with closed cell pipe insulation. Repairs or replacement of this insulation where it is missing and/or damaged is therefore recommended. See illustration below.
