CONFIDENTIAL INSPECTION REPORT

Property Inspected
123 Main Street
Clifton, New Jersey

Commercial Building

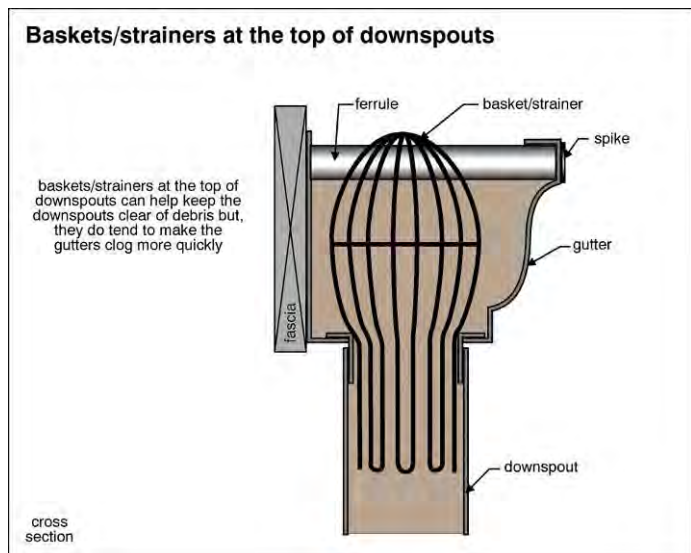
The installation of leaf / debris baskets inside all of the leader openings is recommended to prevent clogging from occurring. See illustration below.

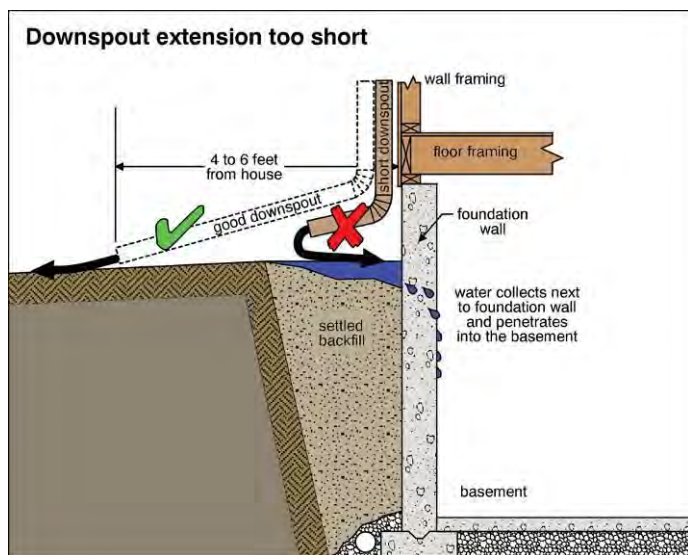
Some of the roof leaders incorrectly terminated at the foundation of the building. See photo #'s 83, 85, 117 & 119. They should discharge 4 to 6 feet away from the foundation. This will help to prevent water entry and excessive moisture in the foundation walls. The installation of 4 inch diameter PVC pipe extensions will be required. See illustration below.

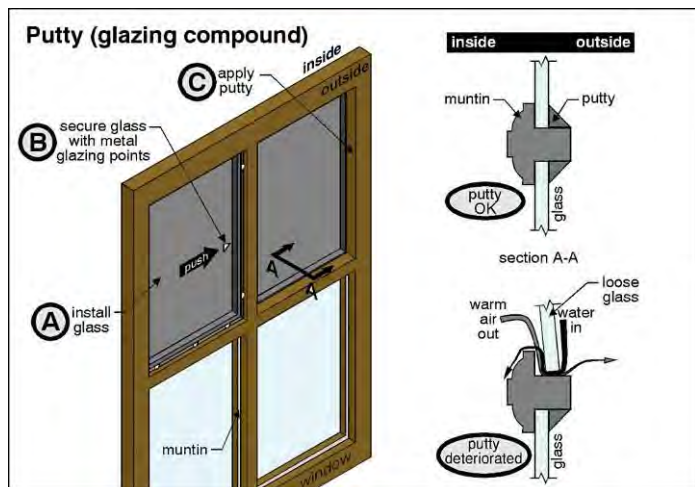
The window glazing compound was loose and/or missing on many windows. Repair or replacement of the glazing compound will be required. See illustration below.

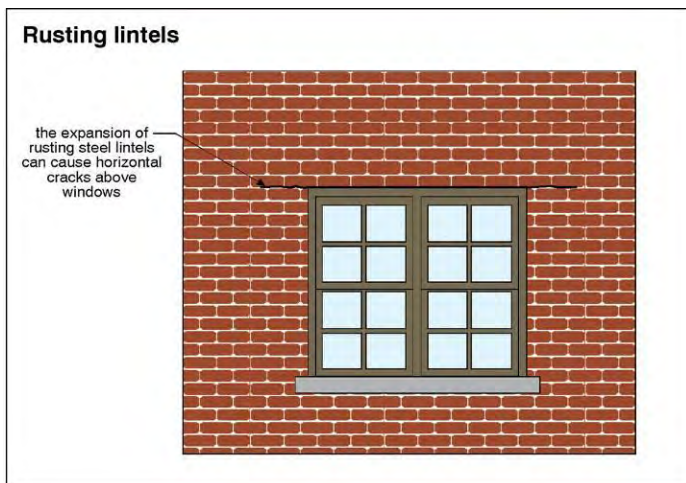
Painting of the steel window lintels, as well as entry door and loading dock door lintels with a rust preventative paint is recommended to prevent deterioration from occurring. See photo # 100 & 101 and illustration below.

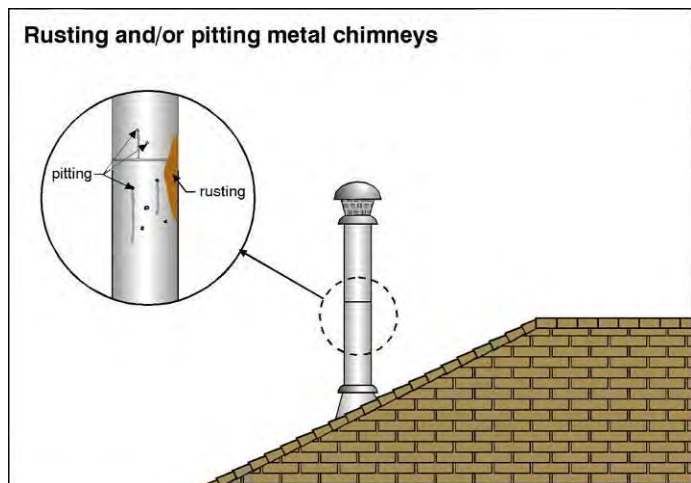
The sheet metal flue pipes/chimneys, including ventilation shafts, were rusting above the roofline. See photo #'s 24 – 27 & 29. Painting the flue pipes/chimneys with a rust preventative paint to prolong their life is recommended. See illustration below.

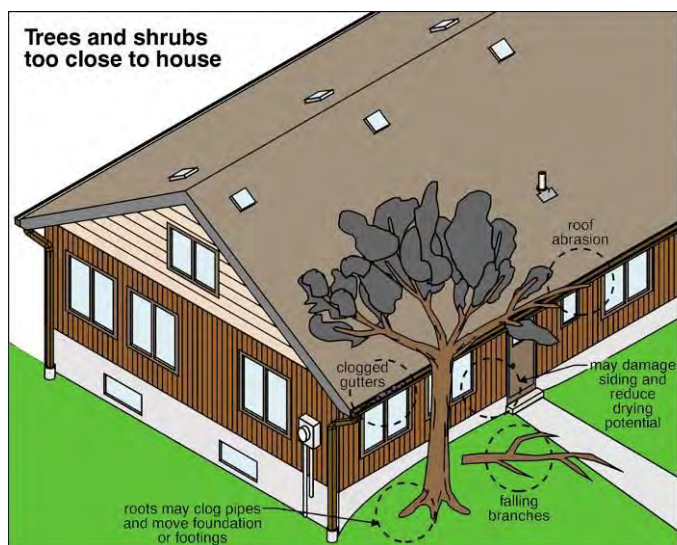
The tree branches overhanging the building should be trimmed approximately 6-feet to 8-feet away from the building to prevent animals and insects from gaining access onto the roof or into the attic and to prevent storm damage to the roofing material from occurring. See illustration below.

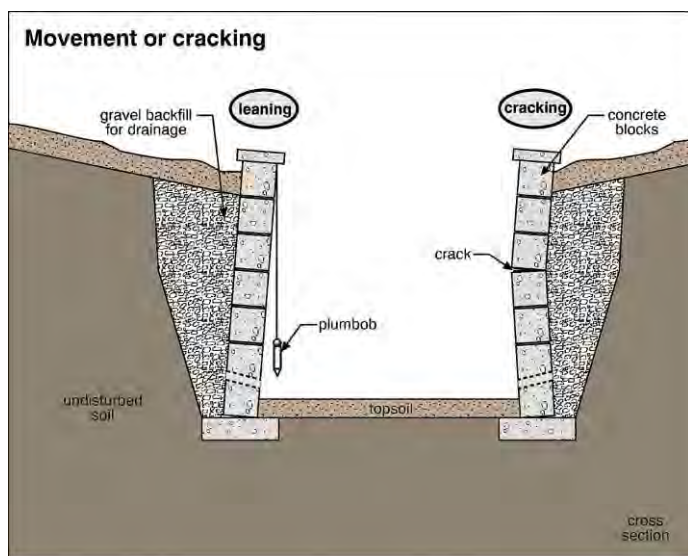
The retaining wall has bowed outward, it has cracked and the top cap on the retaining wall was loose. See photo #'s 201 – 208. It is required that repairs or replacement be conducted for safety reasons. See illustration below.

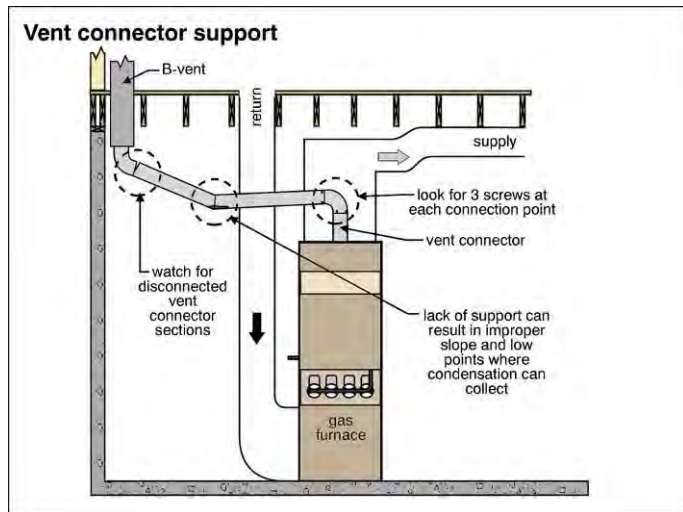
The vent connectors were not properly installed. See photo # 300. Screws were either missing or not installed in the sheet metal vent connectors. Three screws are required in every section of the vent connector. Contacting a licensed plumber for cost estimates on the required repairs will be required prior to contractual limitations. See illustration below.

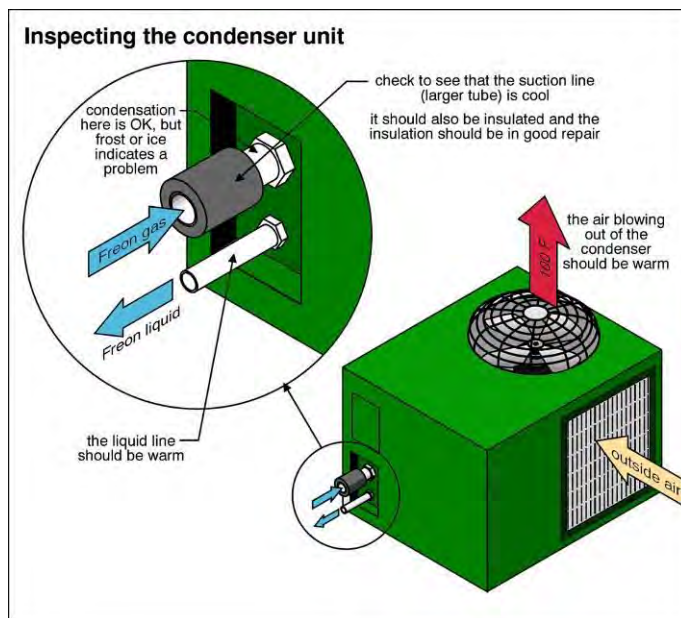
The insulation on the freon suction line, leading to the condensing unit, was damaged and or missing. See photo # 69. The suction line gets cold and should be completely covered with closed cell pipe insulation. Repairs or replacement of this insulation where it is missing and/or damaged is therefore recommended. This is a minor repair. See illustration below.

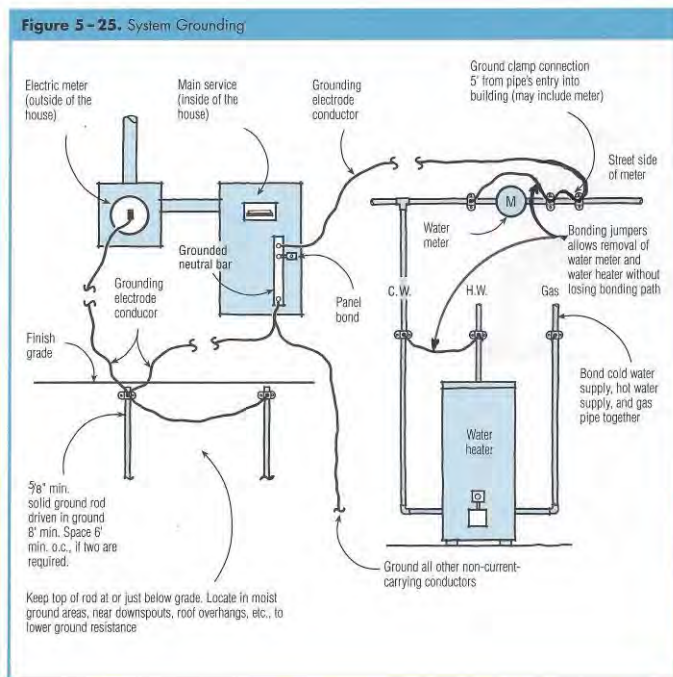
There was no bonding cable installed on the water heater's water supply piping. Its installation is required by current electrical standards. See illustration below.
