building inspection service, inc.

Condition Inspection Report

129 Main Street
Cranford, New Jersey

A specific condition inspection of the above mentioned subject property was conducted on February 15, 2016. It reflects our professional opinion of the Roof, Gutters, Leaders, Property Drainage, Exterior Foundation and Basement Foundation and Framing.

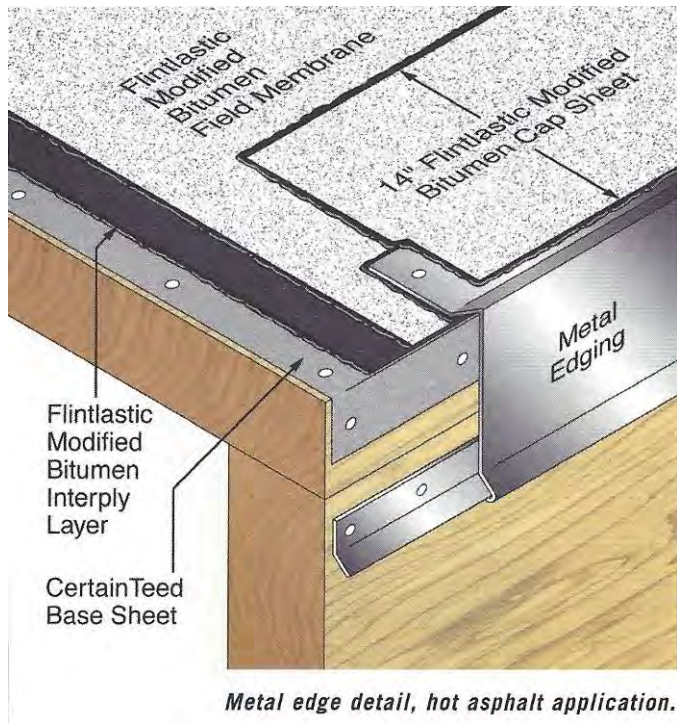
Drip edge flashing was not installed. See photo # 5. The installation of drip edge flashing is recommended to help prevent water entry into the building and rotting of the edge of the roof sheathing from occurring. See illustration below.

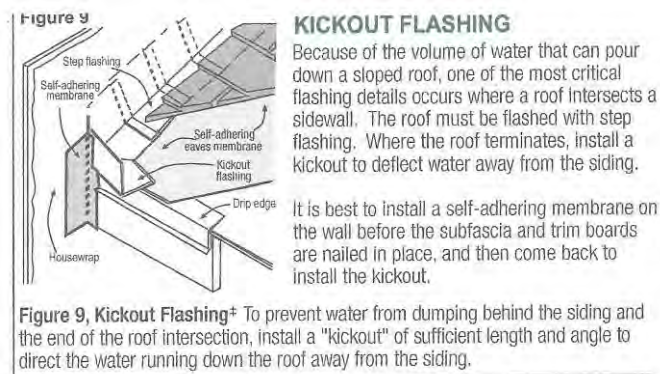
There were no kickout / diverters installed at the bottom of the roof / wall intersection areas which are commonly referred to as side or 'cheek or side walls'. See photo # 6. Accumulating roof water runoff should be directed out and away from the building and into the gutters. Roof-to-wall flashing areas should have a kickout / diverter installed at the bottom termination of the side or cheek wall to insure that water is directed away from siding and other wall surfaces. The installation of kickout / diverters will be required to prevent leaks and water damage from occurring. Obtaining cost estimates for their installation is recommended prior to contractual limitations. See illustration below.

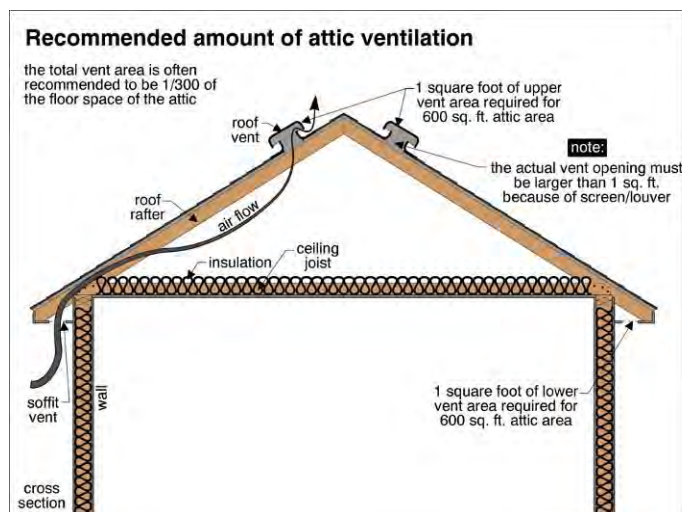
Inadequate roof/attic ventilation was noted. The installation of soffit vents and ridge vents will be required. The improved ventilation will release moisture and lower the temperature in the attic which will prolong the life of the roofing material, help to prevent ice damming from occurring, help to prevent the roof sheathing and rafters from molding or rotting, and help to prevent thermal stress cracking of fiberglass roofing material from occurring. See the articles regarding attic ventilation on our website at www.dicoinspection.com. Click on the Information tab and read Article #'s 6, 7, 9, 12 & 14. See illustration below.

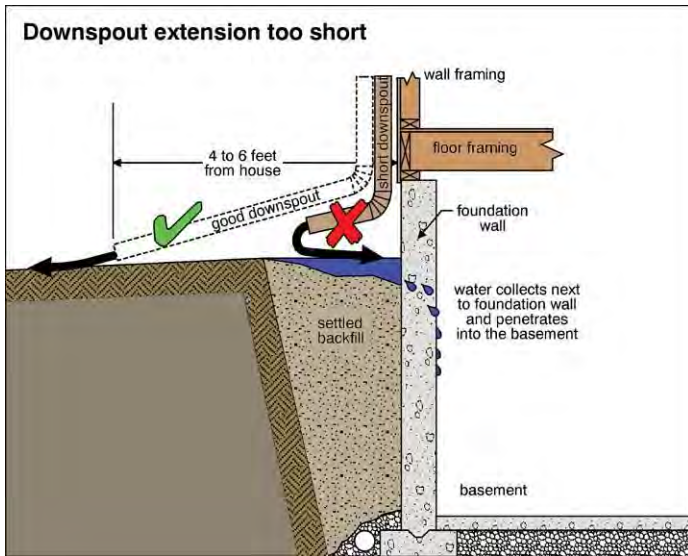
Some of the roof leaders incorrectly terminated at the foundation of the building. See photo # 7. They should discharge 4 to 6 feet away from the foundation. This will help to prevent water entry and excessive moisture in the foundation walls. The installation of 4 inch diameter PVC pipe extensions will be required. See illustration below.

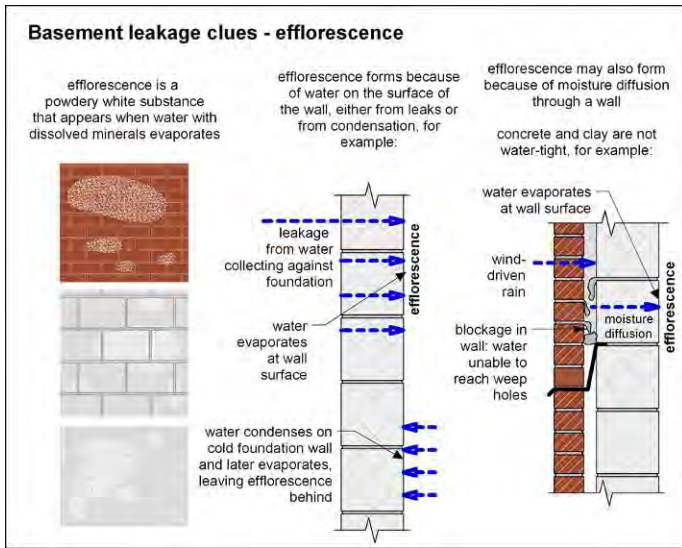
The presence of efflorescence, a condition relating to water seepage through masonry, was seen on the rear foundation walls. See photo # 21 – 25. As water that is inside the foundation walls evaporates, mineral salts are deposited on them leaving behind these crystalline structures. This is a condition conducive to water damage and mold. Corrections to the water entry will be required in order to correct this condition. Efflorescence is rarely a structural concern, however it is a definite sign that water is entering and moving through the foundation walls. It is also an indication that the exterior drainage is inadequate. This can be an easy fix such as directing gutters and leaders to discharge four to six feet away from the foundation. In can also be related to negatively pitched soil on the exterior of the foundation and/or other exterior foundation conditions. The exterior soil should slope / pitch, one inch per foot, eight to twelve feet away from the foundation. The exterior foundation should be well parged / plastered, without

cracks, and it should be well sealed with an approved damp / water proofing material below the exterior soil grade / level. Most of these conditions cannot be observed because they are below the exterior soil grade. Corrections to these conditions and a further evaluation by a structural engineer or a basement waterproofing company are recommended prior to contractual limitations. See illustration below.

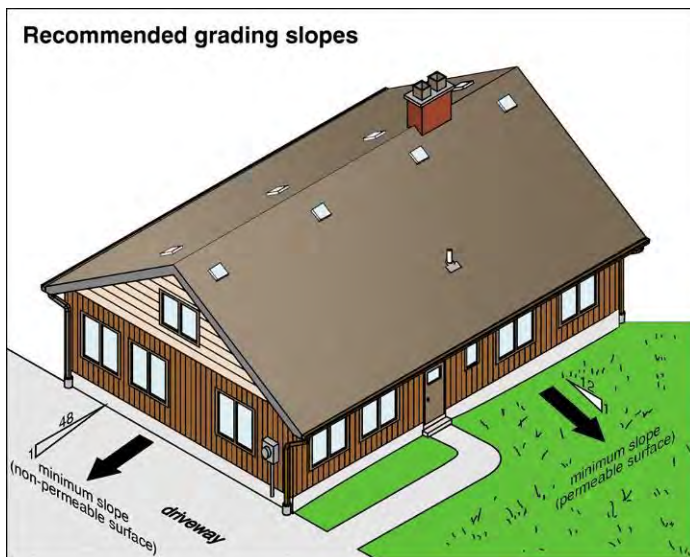
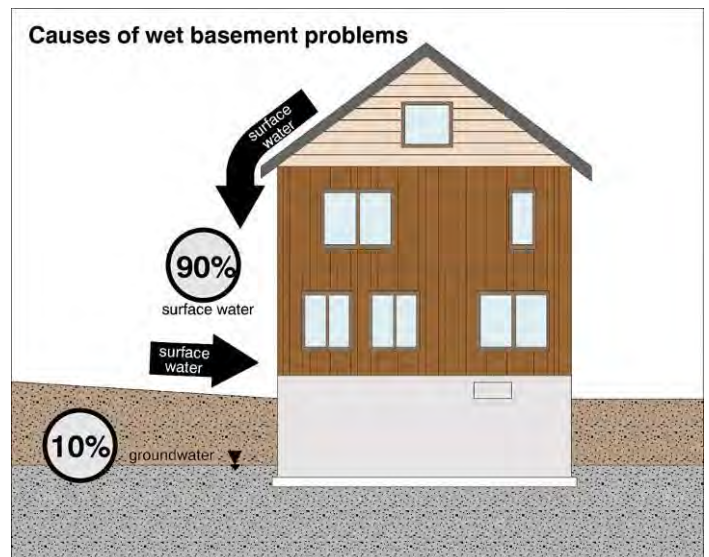
The soil grading on all sides was incorrectly sloped into the foundation rather than away from the foundation. This condition will cause surface water to drain into the building rather than away from the building. Grading of the soil away from the building will be required to help prevent water from draining against the foundation and from entering the interior of the building. The ground adjacent to the foundation wall must be graded to slope away from the building at a ratio of 1:12, meaning that for every 12-foot out horizontally the ground level is to descend 1-foot. This grading requirement is to be applied for a distance of 8-feet or more, measured perpendicular to the foundation wall. See illustrations below.
