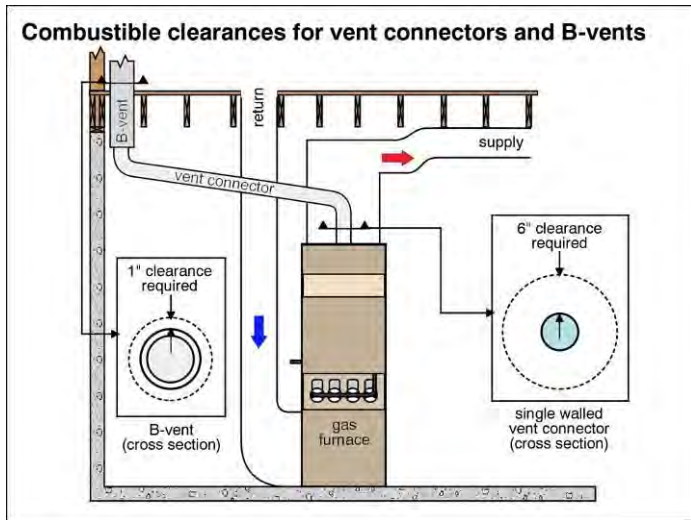
1. The vent connector was too close to combustible materials. See photo #'s 94 & 95. A single wall sheet metal vent connector must be 6-inches or more away from combustible materials and double wall 'B' vents must be 1-inch (or as per the manufacturer's specifications) or more away from combustible materials as required by current plumbing practices and for fire safety reasons. See illustration below.

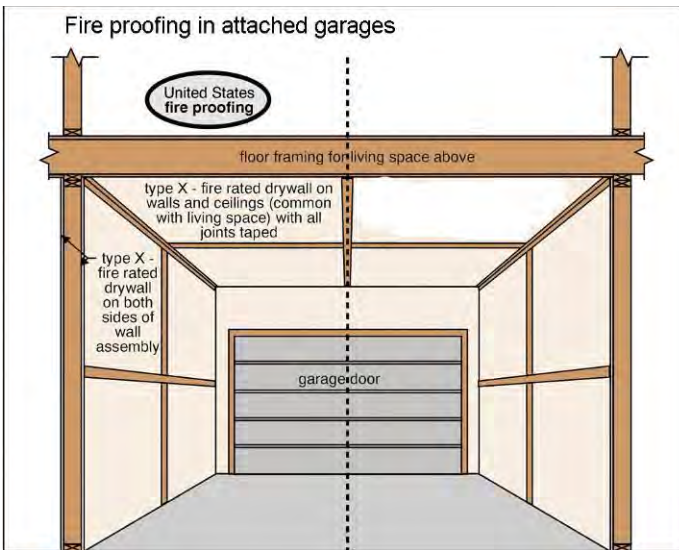
3. The fire collar / sealant was missing around the metal vent piping where it passes through the ceiling firewall. This is a safety concern with repairs required.
4. Current building practices require that no openings in garage ceiling be allowed for fire safety reasons. Covering the larger openings with 1/2-inch fire x drywall and spackle or 5/8 inch fire x drywall and spackle if a living space is above the garage and smaller openings with plaster or a fire retardant caulk or foam will be required for fire and life safety reasons. Checking with the local building department for their requirements is recommended prior to contractual limitations. See illustration below.

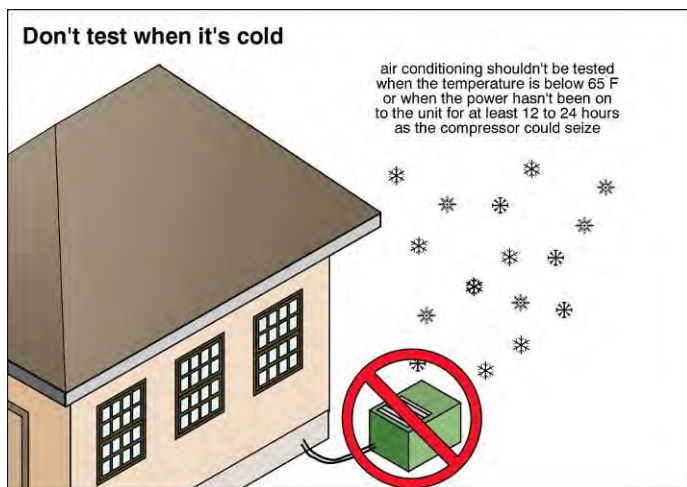
The central air conditioning system was not tested at the time of the inspection because the exterior temperature was below 60 degrees Fahrenheit. It is recommended that a written statement be obtained from the seller to insure the operational condition of this unit in the Spring of the year. See illustration below.

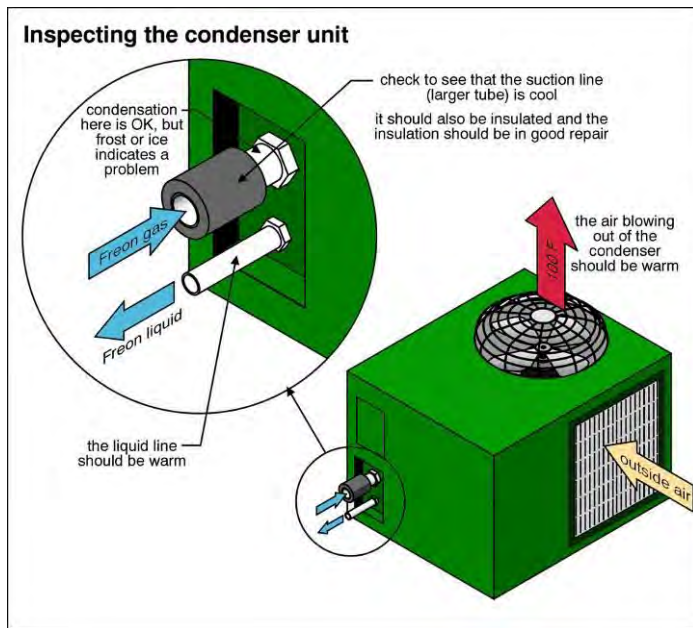
The insulation on the freon suction line, leading to the condensing unit, was damaged and or missing. See photo # 66. The suction line gets cold and should be completely covered with closed cell pipe insulation. Repairs or replacement of this insulation where it is missing and/or damaged is therefore recommended. This is a minor repair. See illustration below.
