building inspection service, inc.

CONFIDENTIAL INSPECTION REPORT

Address of Property
New Jersey

Single Family

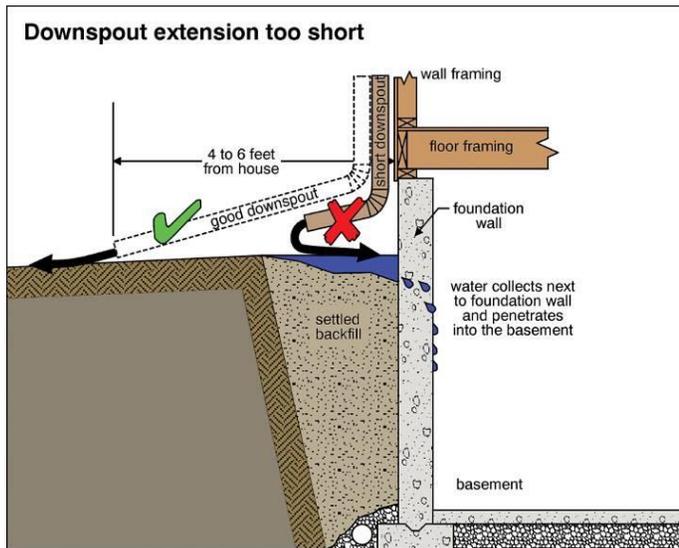
The roof leaders incorrectly terminated at the foundation of the building. See photo #'s 19, 20, 29, 30 & 63. They should discharge 4 to 6 feet away from the foundation. This will help to prevent water entry and excessive moisture in the foundation walls. The installation of 4-inch diameter PVC pipe extensions will be required. Please refer to Article #'s G1 & G2 on our website at <http://www.dicoinspect.com/helpful-articles.html> for additional information on this topic. See illustration below.

It is recommended that the leader on the front left side by the front entrance walkway, be directed into an underground drain line, which would discharge roof runoff away from the building. See photo #'s 13 & 14. Please refer to Article # G2 on our website at <http://www.dicoinspect.com/helpful-articles.html> for additional information on this topic.

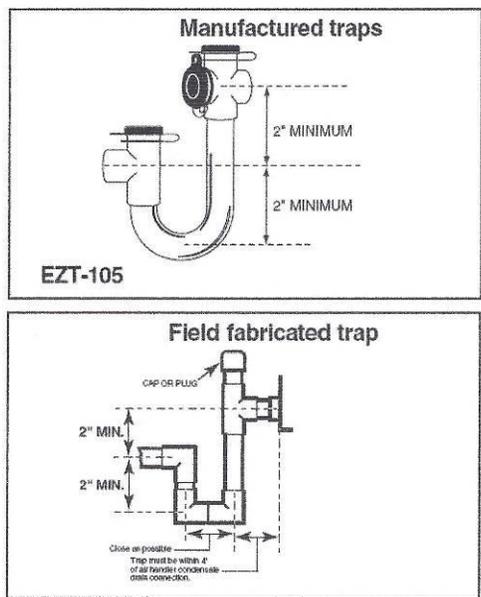
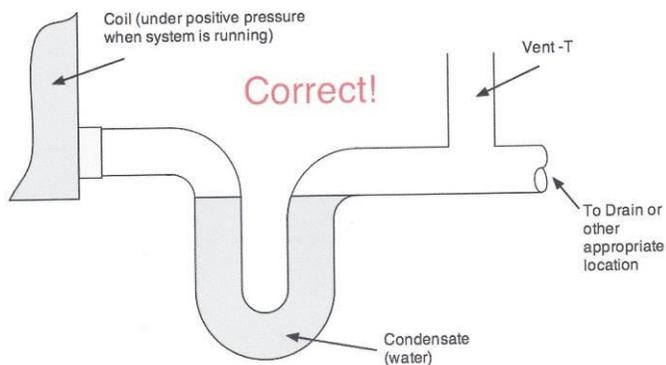
Recommended trap configurations. Illustration from Trane installation manual.

Condensate drain traps were not installed on the condensate drain pipes as required. See photo #'s 90 – 92 & 109. A trap prevents bacteria, radon gas, insects, etc. from entering the evaporator and the indoor air stream. It also helps to improve the drainage of the condensate because it eliminates the positive pressure created when the system is running and prevents back draining of condensate. Repairs by a licensed HVAC or Plumbing contractor will be required. Obtaining cost estimates for any repairs or replacement will be required prior to contractual limitations. See illustrations below.

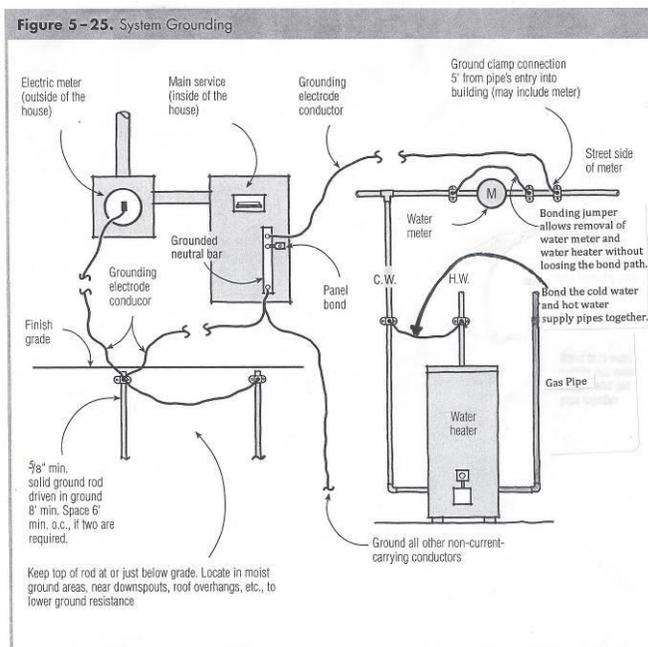
There was no bonding cable installed on the water heater's water supply piping. See photo # 88. Its installation is required by current electrical standards. See illustration below.
