# SIDING

## Common Siding Failures Avoid errors that will cause a fiber-cement job to fail

BY MARK PARLEE

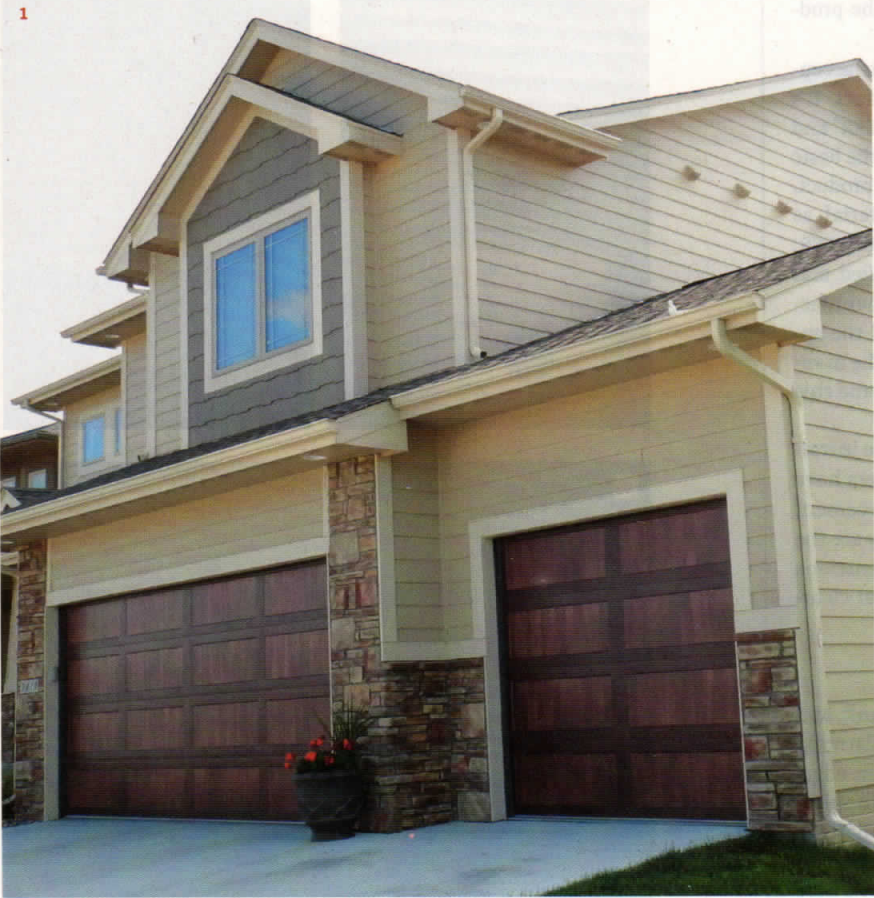
I see a lot of failed siding jobs. The one shown in the photos in this article is typical of the fiber-cement siding jobs I am asked to look at. I could go out right now to hundreds of homes like this one that are in a similar condition. Each one, like this house, usually looks fine from a distance (1), but after examining the house up close, I see the same installation errors again and again. For some of the jobs, I am called out to investigate because they have gone to litigation. For others, it's a homeowner complaint. But almost all of them are very expensive to repair.

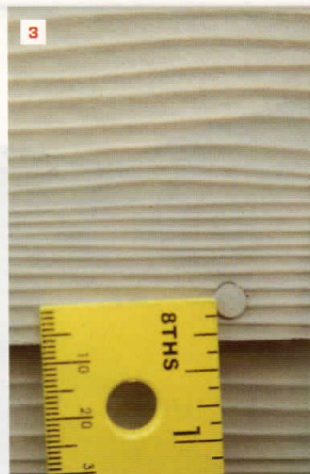
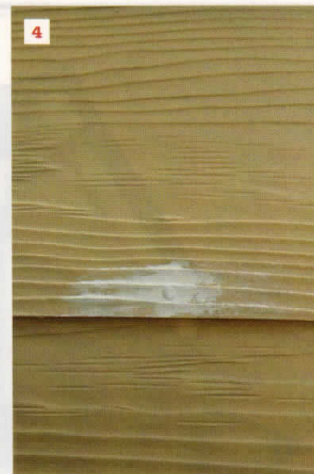
The material used here was MaxTile's MaxiPlank; and according to its ESR, exposed fasteners (face nails) must be placed at least  $\frac{3}{4}$  inch up from the bottom edge. Mostly, this job had been blind-nailed to begin with, but the installers had occasionally placed face nails to hold boards down, and these were only about  $\frac{3}{8}$  inch from the bottom edge (3). At least the nail shown here had been set more or less flush to the surface, whereas all the face nails the builder had retrofit not only were too close to the bottom edge, but also had been over-driven—and the divots had been filled with spackle (4).

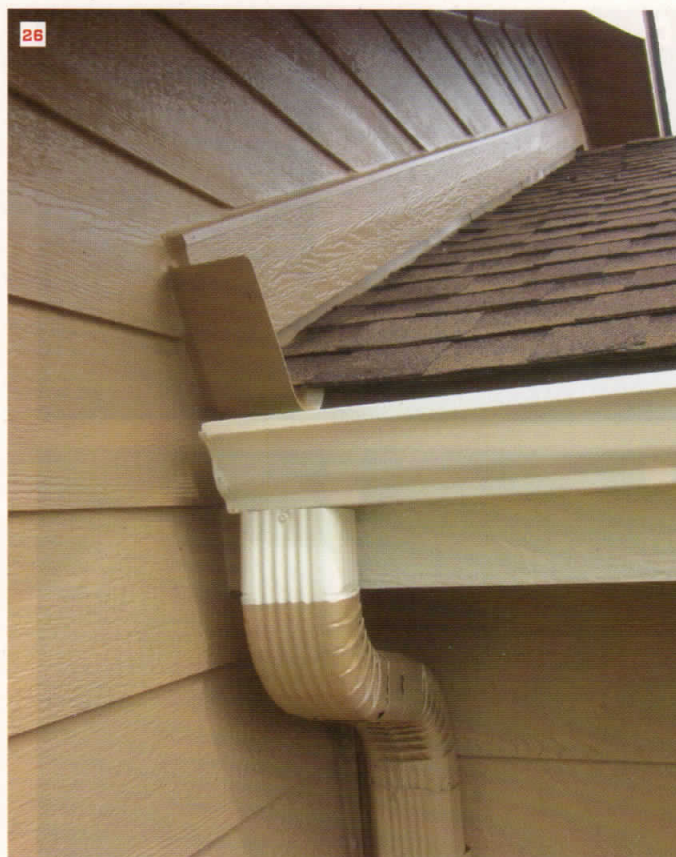
A true kick-out flashing, as shown in this photo of one of my siding jobs (26), is a large flashing that gathers water and directs it into the gutter. Note, too, how I detail the rake: I run a trim board along the rake, keeping this the required distance above the roof surface, and bring my siding board down to the trim, maintaining a ¼-inch gap that gets caulked. Details like this let me stay profitable and allow me to sleep at night.
