ROOFING

Common Roofing Errors Details that matter on asphalt shingle roofs

BY MARK PARLEE

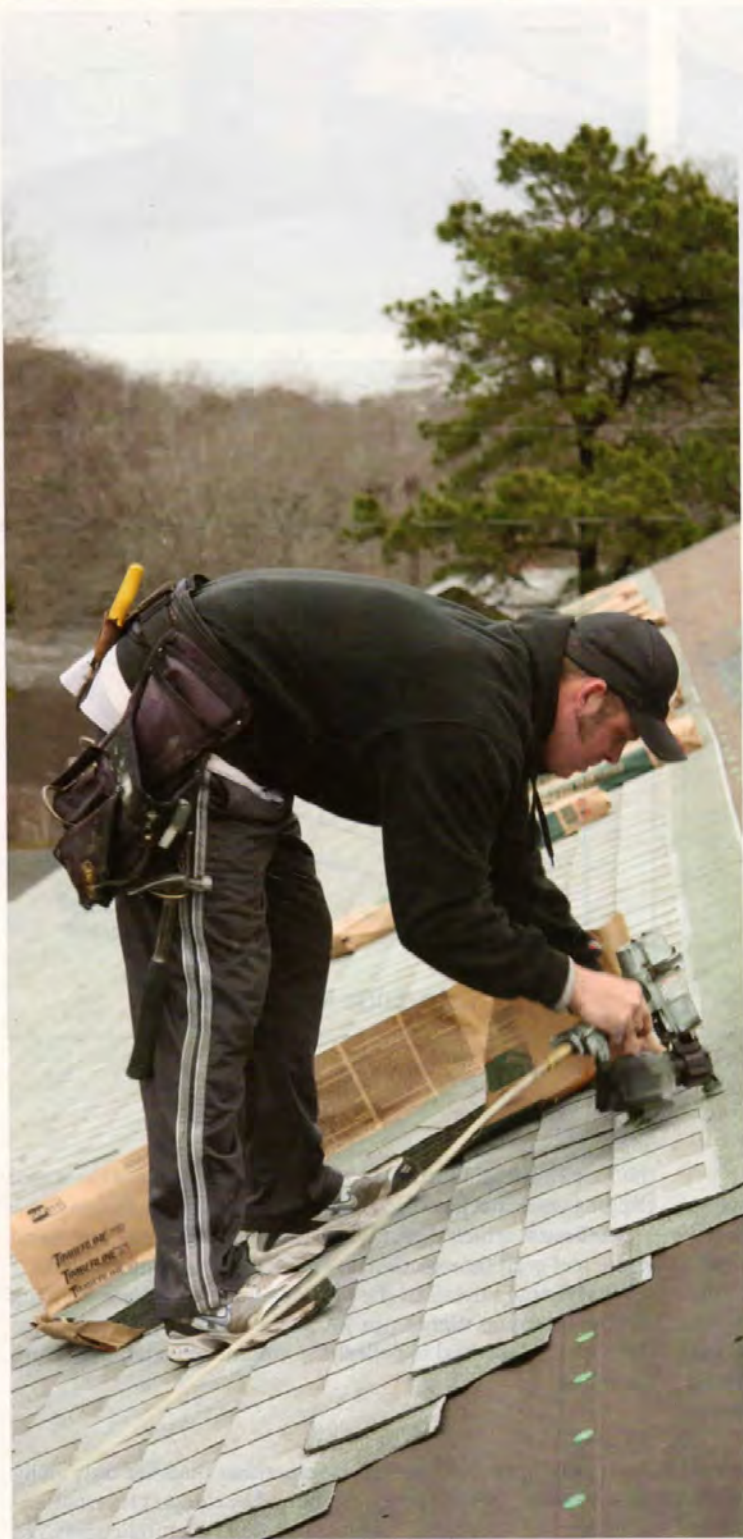
The photos on the following pages show the condition of the roof when I saw it three years after it had been installed, and it was immediately evident to me that the roofer had done an exceptionally poor job. The shingles themselves were a decent-quality laminated product, as is usually the case with the roofs I see; however, it's not the shingles but the detailing—namely of the flashings—that determines the quality of an asphalt shingle roof.

All of the leaks stemmed from poor attention to detail when the shingles were being installed and flashed. These problems included the following:

- There had been a complete failure to install a new step flashing or even to integrate the new shingles with the existing step flashing.
- Shingles had been laid without an adequate offset between courses.
- Shingles had been nailed haphazardly. In many cases, no nails were evident at all, and in others, nails were overdriven or crooked.
- Shingles had not been accurately cut to fit around the roof vents.
- No drip-edge had been installed along any of the roof edges.
- No plumbing vent boots had been installed. Instead, these penetrations had been “black jacked”—asphalt roof cement had simply been smeared around the bases of the vent pipes.

With so many problems, the only solution I could recommend was a complete replacement of the entire roof. What a terrible waste of a three-year-old roof.

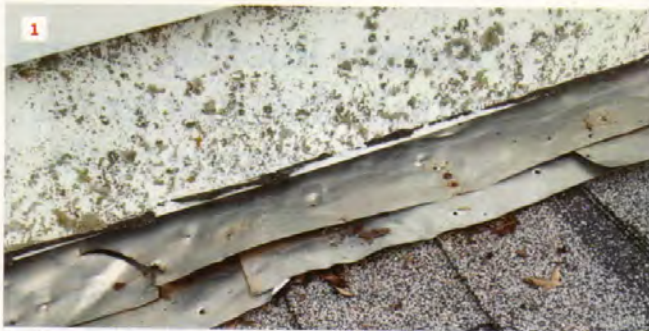
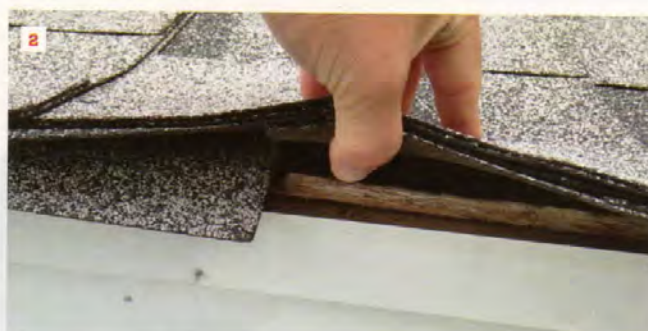
On this job, the roofer completely ignored the existing step flashing and merely tucked the new shingles beneath both the step flashing and the counterflashing (1). These existing flashings were in rough shape and should have been replaced. If the roofer had even made an effort to interlace the shingles between the steps, at least there would not have been a direct leakage path between the shingle surface and the old flashing. As it was, the ceiling areas below this intersection suffered the most damage from water leaks.

It was obvious that the roofer did not want to deal with the stucco that came down over the sidewall flashing. Had the original counterflashing been addressed more like the counterflashing shown in

the “Step Flashing” illustration (above left), destruction of the stucco cladding would not have been necessary to replace the flashings.

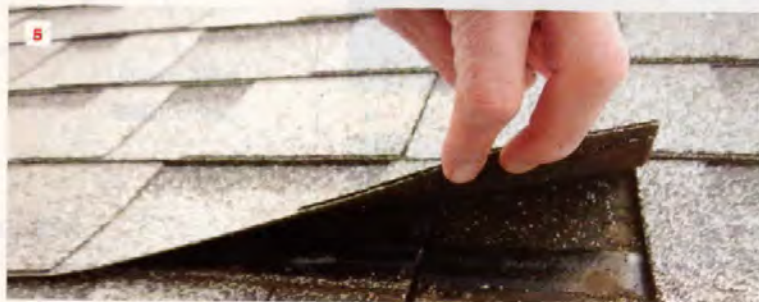
Shingle nailing. When the author inspected the project, no nails were evident at the ends of many of the shingles (5). The standard nailing for asphalt shingles is a four-nail pattern, with nails placed 1 inch from each end of each shingle and then two nails placed 12 inches from the end nails, as shown in the top of the “Shingle Nailing” illustration (above left). On laminated shingles, this nail spacing is not as immediately apparent as it is on three-tab shingles, where the nails are placed above the cutouts. In high-wind locations and steep-slope applications, a six-nail pattern should be used, as shown in the bottom of the same illustration (above left).

Most asphalt shingle roofs can be fastened with a four-nail pattern. The key is to keep to a consistent pattern—1 inch from the edges and uniformly spaced across the shingle length.

On this roof, the nailing was sporadic, and in many places, there were no nails visible at all. This is often the result of installers trying to blow through an installation as fast as possible, machine-gunning their way across the roof with pneumatic roofing nailers. When this happens, the likelihood for overdriving nails and driving nails crooked increases (see Properly Driven Nails, top right).

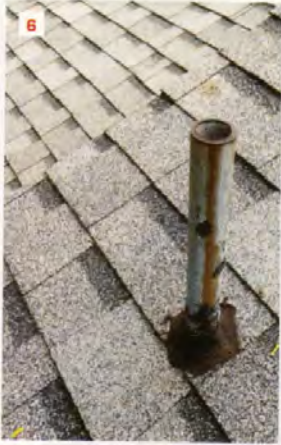
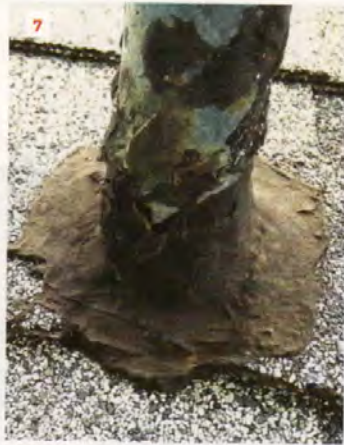
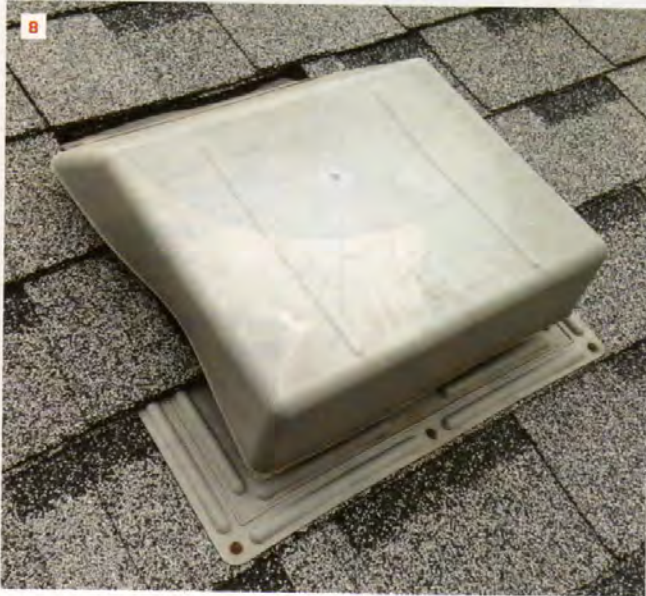
Penetrations. “Black jacked” plumbing vents are all too common, but this is not a good way to flash a roof penetration (6). Roofing cement dries out and becomes brittle and will crack. Also, gaps and thin spots open up as the cement dries out and these essentially create funnels running straight into the roof assembly (7). Also shown here is a very poor installation of a self-flashing roof vent (8). The shingles were not cut carefully around the vent but were instead jammed up against the vent, distorting the hood.

Any roof penetrations, including plumbing vents, roof vents, chimneys, and skylights, present direct opportunities for leaks. Plumbing vents and pop-in roof vents are the most common problem areas, and unfortunately, on a lot of reroofs, very little effort is paid to these other than cutting the shingles around them—usually quickly, while running shingle courses.
