BY MARK PARLEE

## How to Destroy a Wall In Two Easy Steps

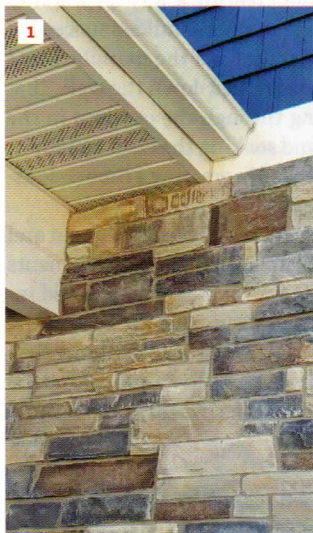
There was little evidence on the outside of the building of a significant problem (1). The exterior cladding consisted of vinyl siding covering the second-story walls, and manufactured stone covering the first-floor walls. Both claddings are incredibly resilient. This particular stone was varicolored with highlights that completely hid any efflorescence (the leaching of minerals onto the surface of masonry) that would have been a sure sign of water problems. But I didn't need to see damage on the outside of the cladding to know that there could be damage behind it. Installing kick-out flashings poorly—or not installing them at all—is a common mistake that allows bulk water into the wall cavity. There was no question in my mind we had to open up the wall to investigate further.

From the outside of the home, there was little damage evident, certainly nothing that indicated that this single section of wall would eventually require \$4,000 to \$6,000 in repairs.

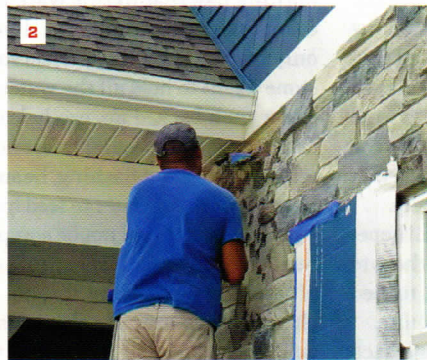
As soon as we started to take apart the wall, we found a good-quality drainage mat over a weather barrier (2). That was a good sign. In theory, this dimpled mat would create a capillary break to interrupt the flow of water through the porous masonry cladding and allow it to flow down through the drainage mat and out the bottom of the wall. Nevertheless, behind these products, the OSB sheathing was rotten (3). This was not too surprising given the lack of a kick out to divert the water. Even with a good drainage plane, the amount of water draining off a roof can overwhelm a drainage system and soak the sheathing.

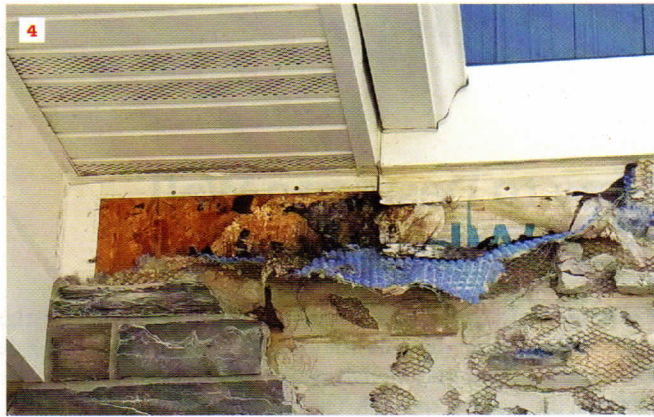
In this case, the bottom channel on the vinyl siding above the roof was acting like a tiny gutter to collect water flowing down the wall and surgically inject it onto the top edge of the frieze board that divided the vinyl and manufactured-stone sections of the wall (4). There was no Z-flashing on this frieze board, either, so chances were high that a significant amount of that water was draining to the back of the frieze and soaking the OSB from above. The drainage mat started below this frieze board, so it wasn't providing any help.

The repair would not be complicated. We needed to tear out and replace all the rotten sheathing and replace all the same elements of the exterior cladding system. This time, however, we would include the two missing elements: a weep screed at the base of the wall, and a kick-out flashing at the base of the roof-wall intersection. In this case, the kick out would need to be installed behind the vinyl J-bead so any water running down that "mini gutter" would be diverted into the roof gutter.

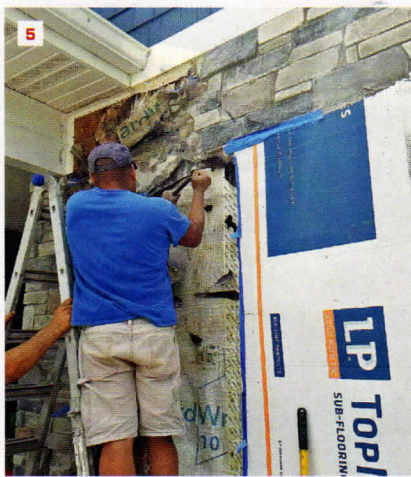
We continued to take the wall apart, stripping the stone back and hoping to come to the end of the rot (5). No such luck. We opened up the entire wall without finding any solid sheathing (6). The worst rot was at the base of the wall (7), illustrating clearly why details matter.

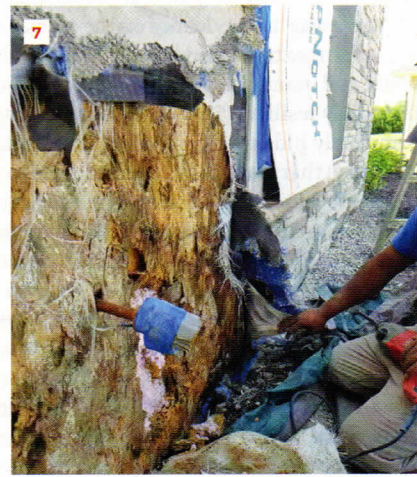
A wonderful drainage mat turns out to be a complete waste of money if you leave out weeps at the base of the wall. There was

nothing like that in this wall. By not creating a way for water to drain out the bottom of the drainage mat, the builder succeeded only in creating a larger reservoir (larger than the manufactured stone itself) to hold all the water that drained down the wall. That water then backed up, easily leaking through the overlaps in the drainage mat and weather barrier and soaking the OSB. Moreover, without a kick-out flashing, he succeeded in creating a tremendously large source of water to feed his reservoir.
