CONFIDENTIAL INSPECTION REPORT

Property Inspected
123 Main Street
Clifton, New Jersey

Commercial Building

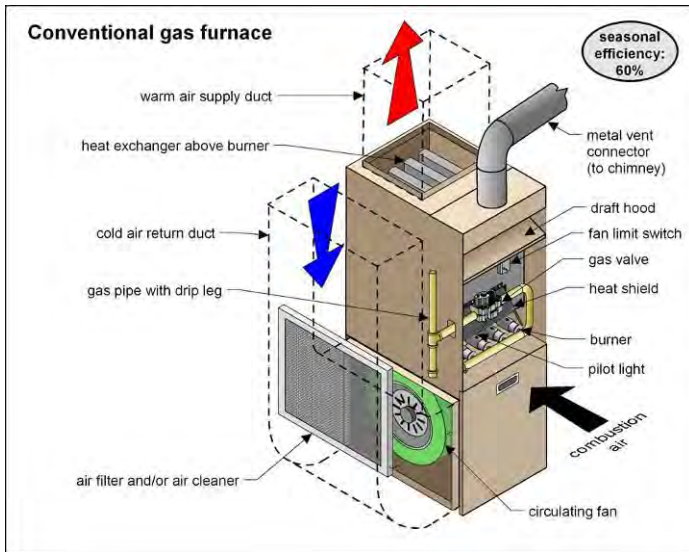
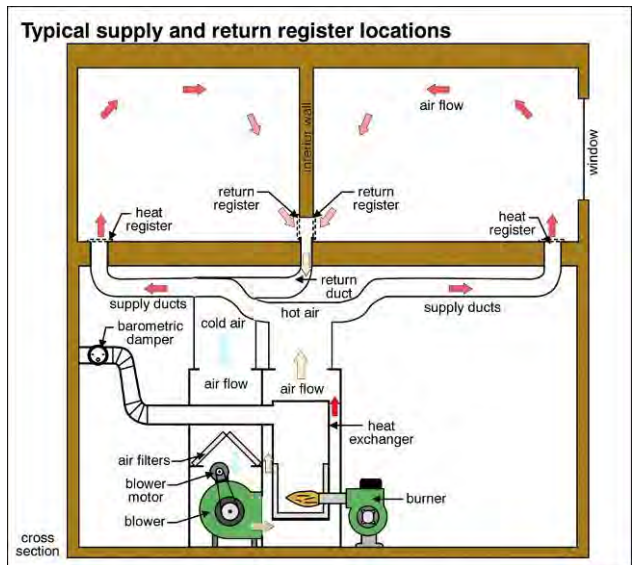
The two Rheem, gas fired, forced air furnaces were 1 zone heating systems with a capacity of 150,000 BTUs each. See photo #'s 371 – 373 and illustrations below. (It is recommended that the local utility company be contacted to obtain a worry free service contract. This is a very worthwhile contract that covers many common heating system repairs as well as cleaning any rust scale from the burners.)

The heating systems were in serviceable condition at the time of the inspection.

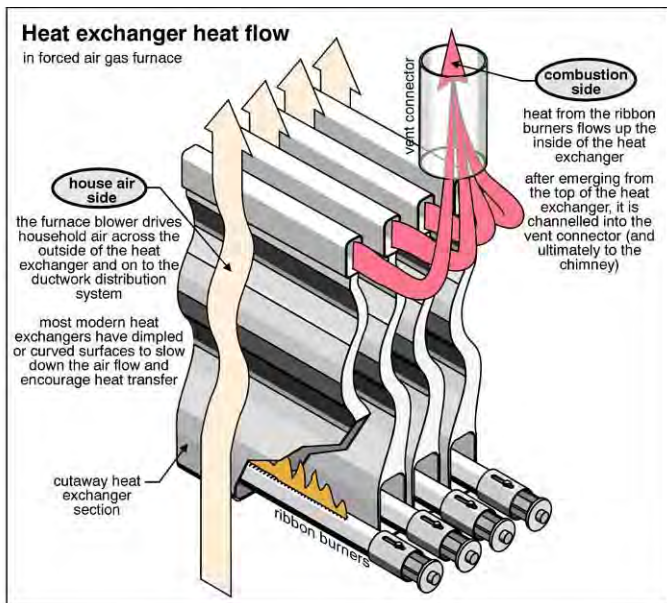
No flue gas leakage through the furnace heat exchanger was noted when tested with the TIF 8800 combustion gas detector. The cells of the furnace heat exchanger, which were visible above the burner rack, were visually inspected with a mirror and flashlight. No cracks or holes could be seen. This inspection is not fail safe and cracks or holes could exist in areas, which were not visible to the inspector. Therefore, a further inspection by the local gas utility company or a heating and air conditioning contractor may be desired. See illustration below.

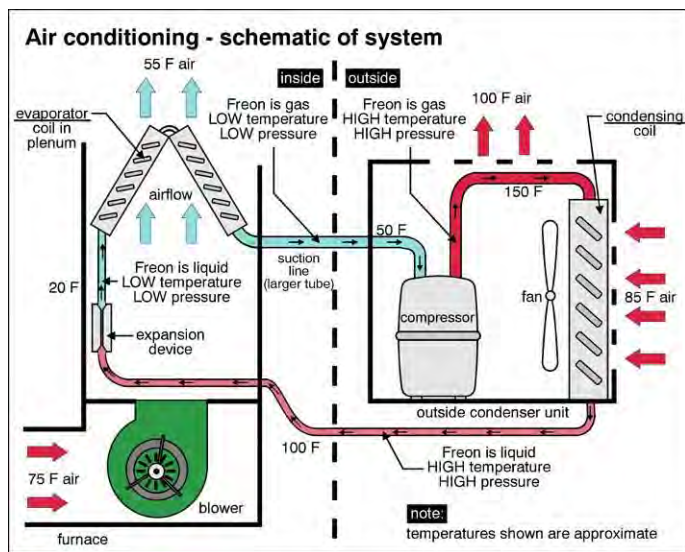
There was a Carrier central air conditioner condenser installed. See photo #'s 65 – 68. This unit had an approximate 5 ton cooling capacity. See illustration below.

The air conditioner appliance was manufactured approximately 21 years ago. The age of this appliance is the inspector's 'best guess'. It is based on the sometimes sketchy nameplate information if available, by the general appearance of the heating system, or by the age of the building in comparison to the typical life expectancy of the air conditioning system installed. The average life expectancy of a condenser is 10 years for a standard condenser, 15 years for a high quality condenser and 20 to 25 years for a scroll type compressor. The year of manufacture is very close to the installation date. Checking with the owner of the building maybe desired to obtain the contract from the HVAC installation company, which would verify its installation date.

The central air conditioning system was not tested at the time of the inspection because the exterior temperature was below 60 degrees Fahrenheit. It is recommended that a written statement be obtained from the seller to insure the operational condition of this unit in the Spring of the year. See illustration below.
