# SIDING

## Common Siding Failures Avoid errors that will cause a fiber-cement job to fail

BY MARK PARLEE

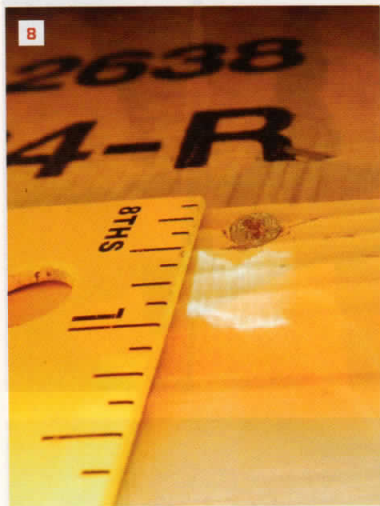
For blind nailing, the ESR specifies that fasteners must be placed a minimum of 1 inch down from the top edge of the board, and a minimum of  $\frac{3}{8}$  inch from the ends. My inspection showed that a majority of the nails were much closer to the top edge (8) and many were overdriven (9).

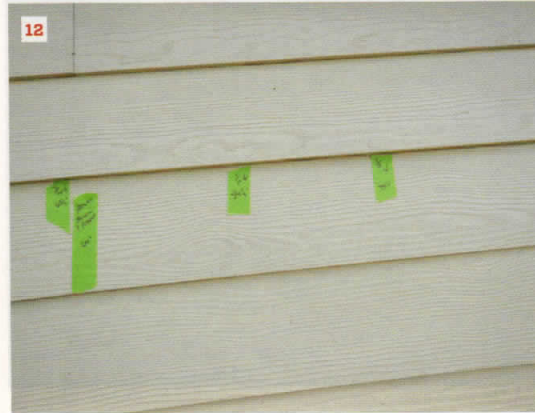
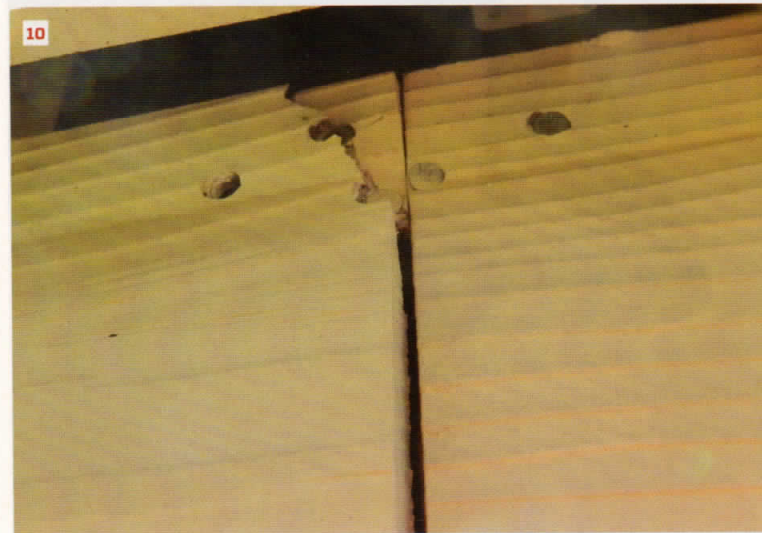
The reason for requiring a minimum distance from board edges and ends is clear: When a fastener is placed too close to an edge, the material tends to break around the fastener (10, 11) when boards expand and contract with changes in temperature, or when wind forces push and pull on the material. The vibration caused by loose boards fluttering in the wind no doubt accelerated this failure and is why so many of the fasteners on this job had completely failed.

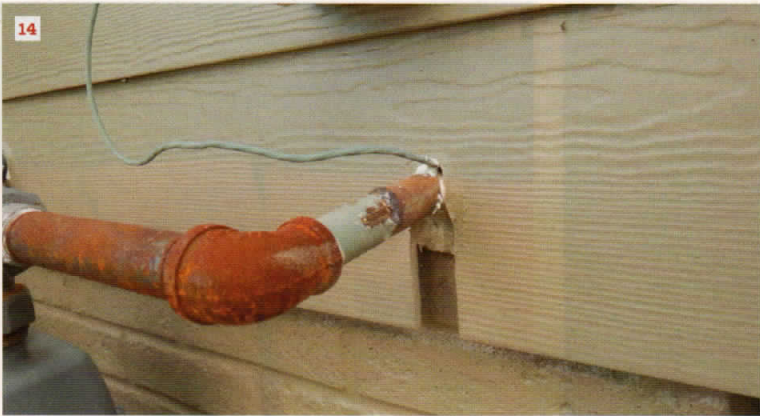
There were a number of egregious water-detailing problems too. One of the worst was a siding break made directly above a dryer vent (13). Water leaking through this joint hit the vent pipe and followed it to the interior, where, not surprisingly, we found water marks. At all the other penetrations—at the gas line near the meter (14) and the hose bib (15)—the siding had simply been slotted around the pipe or vent, which not only looks bad, but also leaves the wall open to serious water and air leaks.

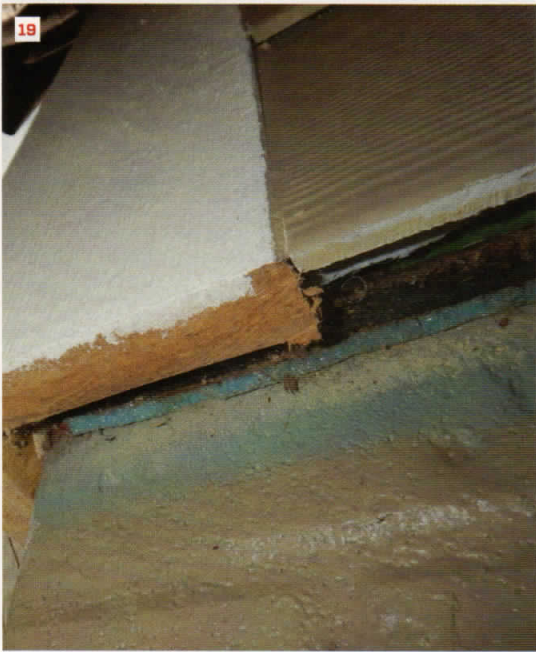
**Cut edges.** The installers on this job also failed to prime the cut ends of siding and trim boards, as specified in the manufacturer's instructions to protect the material from water (18). This is particularly important for exposed edges at the base of the wall (19). Water running down the face of the wall can turn under that lower edge, and splash-back will further wet this area.
