# When Block Foundations Go Bad

Steel bracing and improved drainage  
give new life to cracked  
and wet walls

by Donald V. Cohen

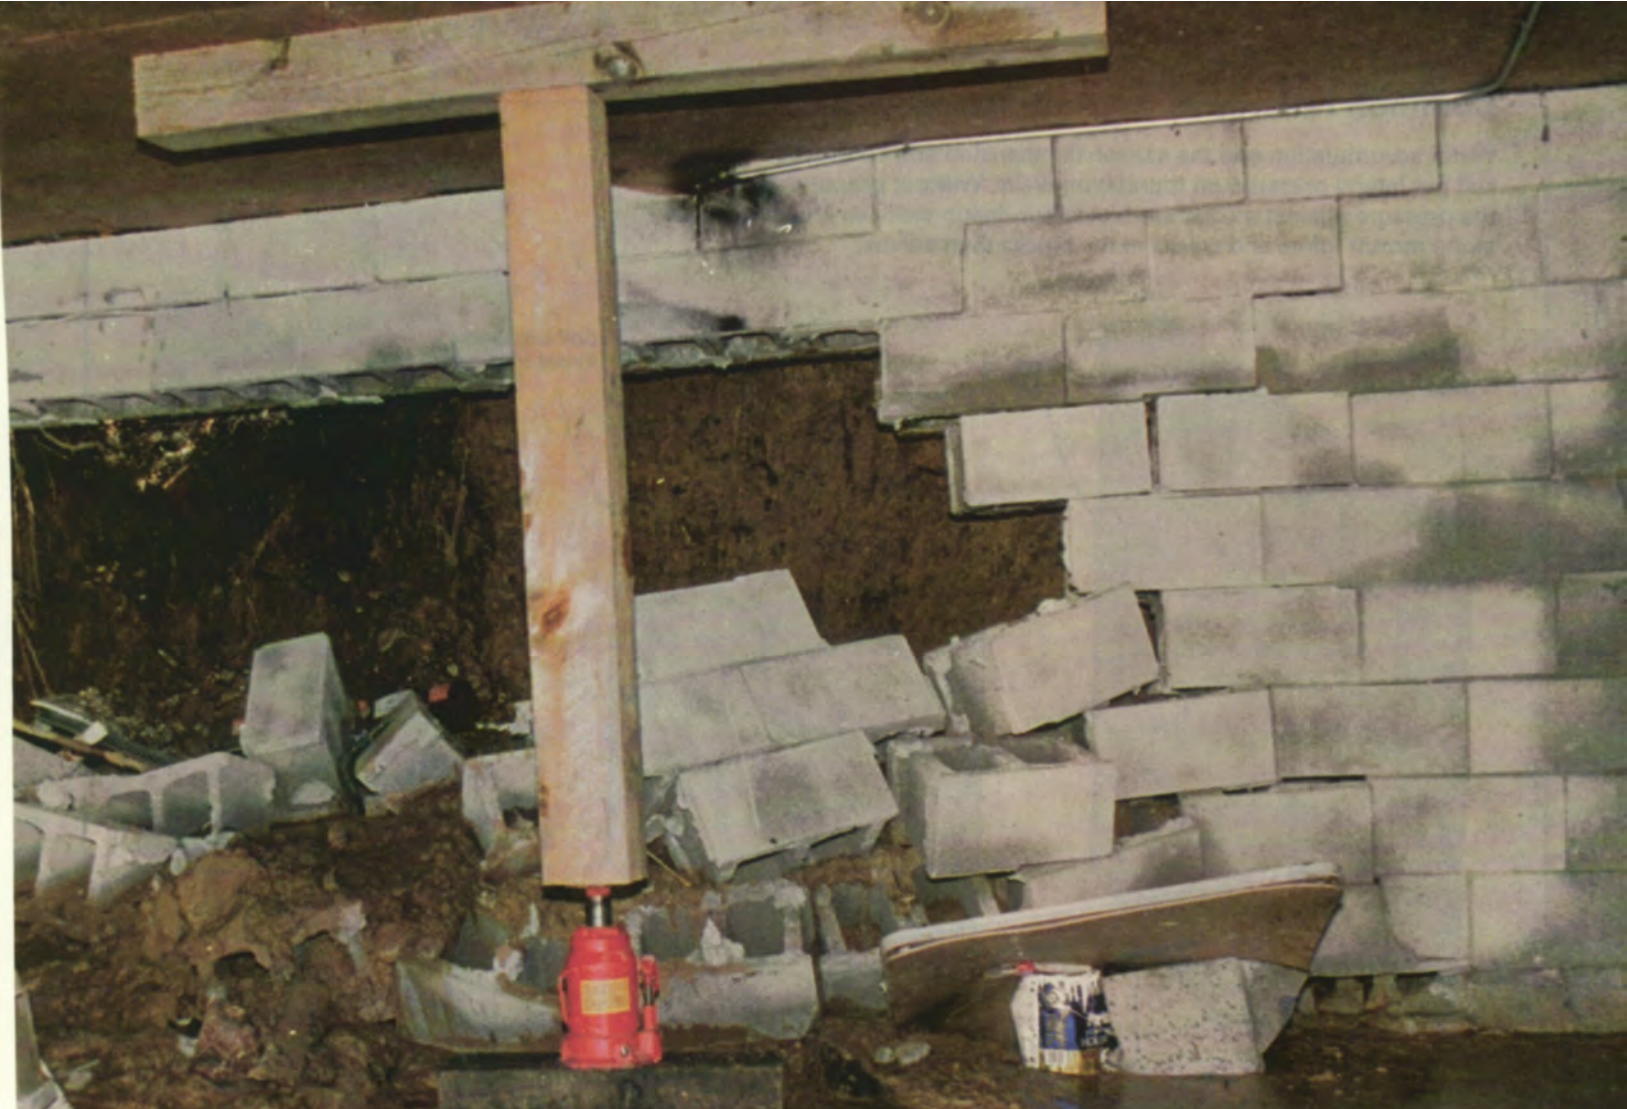
## HOW DID MY BASEMENT BECOME A SWIMMING POOL?

### Soil pressure can push a block wall off its footings

Without proper drainage, water gathers in the soil surrounding foundation walls, often finding its way into the basement. Sometimes disaster is unavoidable, as in the photo above, shot after a storm dumped 6 in. of rain in three hours. Other times, pressure builds slowly, particularly during freeze/thaw cycles. The drawing at right illustrates how soil pressure can tip foundation walls inward, cracking the mortar joints. Any wall displaced more than 1 in. from a plumb position must be excavated. Walls displaced less than 1 in. can be braced from inside.

This is not to say that concrete-block foundations are always a bad idea. They can perform well with proper drainage and appropriate reinforcement, but these conditions are not always present. Gradually, time and the elements can undermine the health of a block foundation, even a well-built one, a fact I am reminded of when doing inspections for prospective home buyers. I constantly see wet basements, or foundation walls that have cracked, buckled, tipped and sometimes even collapsed (photo above).

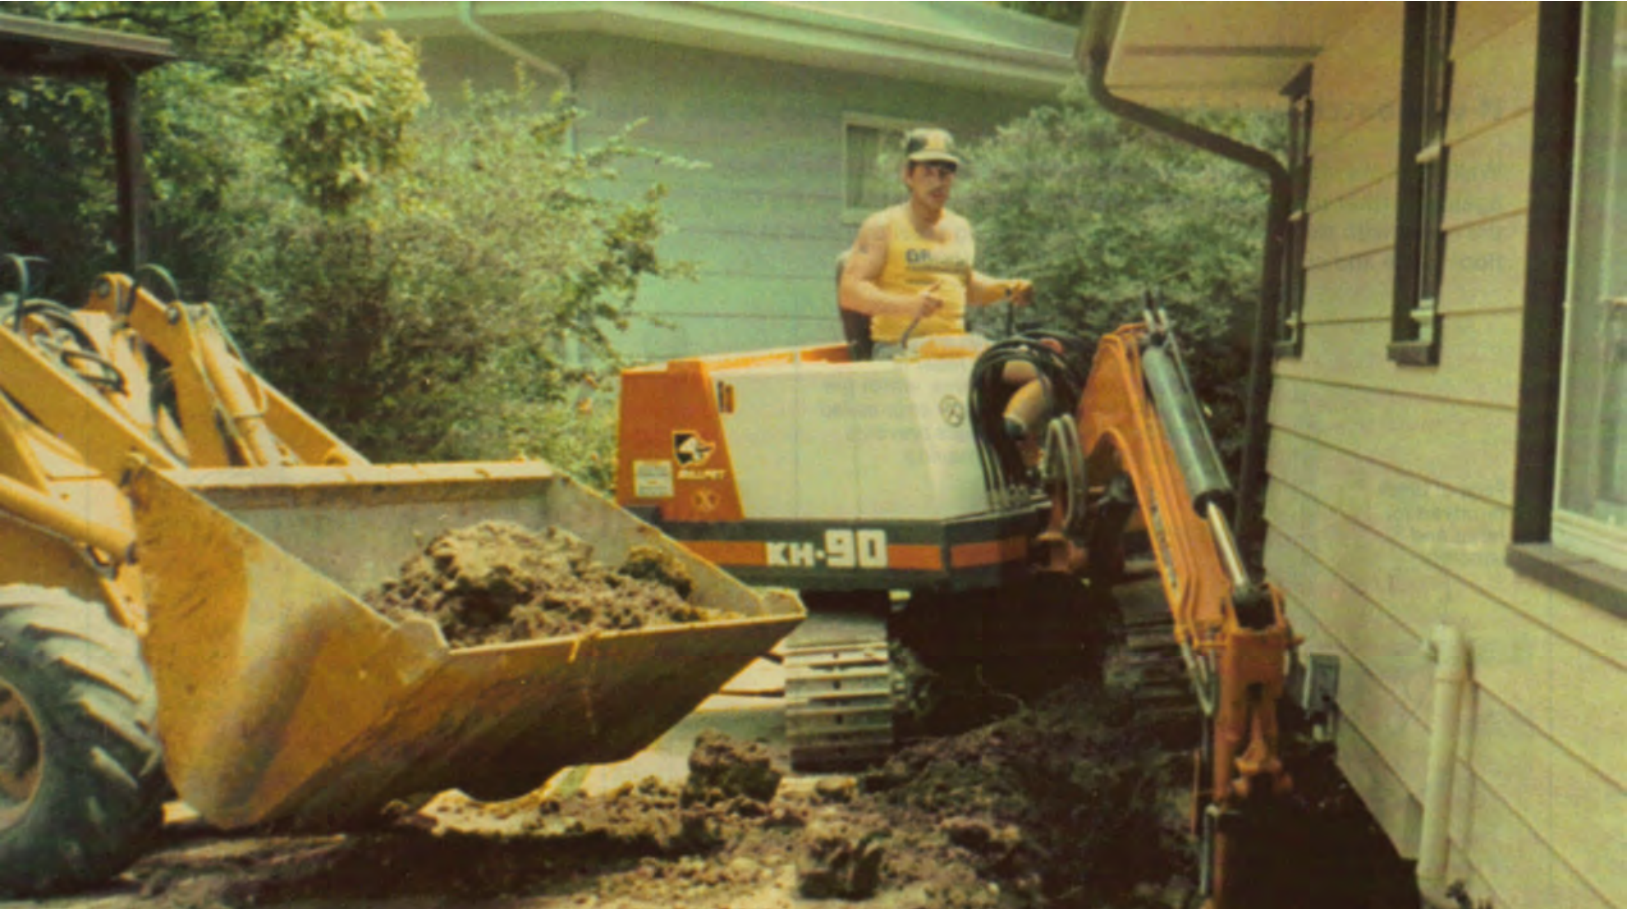
## SOMETIMES YOU HAVE TO DIG

### Excavation is the last resort

*It's expensive, but sometimes excavating the foundation is the only way to fix chronic water problems and severely damaged walls. After the walls are replumbed and braced, and before backfilling, the exterior of the wall should be coated with fibrated asphalt cement, then covered with 6-mil plastic sheeting. Drainage also should be added at the footing if none exists.*

**Walls displaced more than 1 in. must be excavated and replumbed**—If water problems go unchecked, the accompanying seasonal expansion and contraction of soil can wreak havoc on foundation walls, sometimes causing severe displacement. Building-code officials here in Wisconsin require any foundation wall displaced 1 in. or more to be excavated and jacked back to plumb (photo facing page).

After the wall is excavated but before it is jacked or pushed back in place, cracked joints must be cleared of mortar to release the joint and to straighten the wall. With the wall replumbed, the joints must be filled with new mortar. It's important to remember that excavating a finished wall is not enough. Any wall that has been excavated and repaired must be braced or reinforced to prevent future failure. Once the excavated wall has been repaired and before it is backfilled, it's also a good idea to add a drainage system or to repair the existing one (drawings right, facing page).

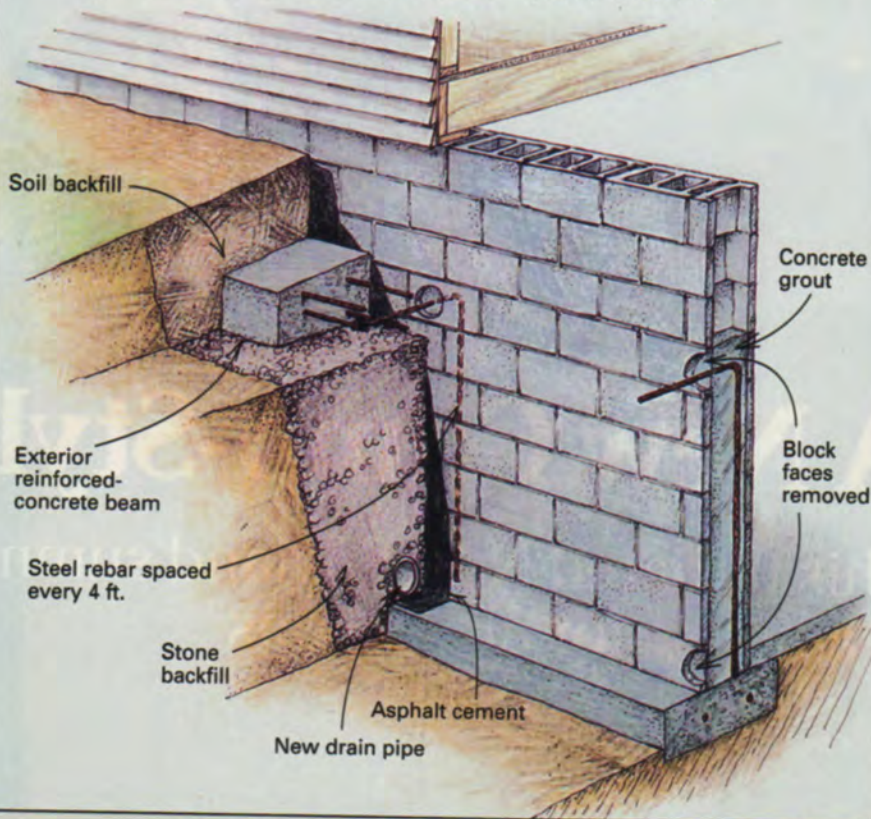
**Patented grade-beam repair.** A displaced wall that has been excavated and repaired must be reinforced against future failure. One method is to excavate and install a concrete grade beam. The beam is connected to concrete and to rebar placed inside the block cores.

## A reinforced-concrete grade beam braces walls after excavation

For severely displaced walls, a Milwaukee-area contractor has developed—and patented—an alternative to traditional concrete-block foundation repairs. The repair involves excavating the foundation, inserting steel rebar into the core of the wall and attaching the rebar to a horizontal, reinforced-concrete grade beam (drawing below). The grade beam is designed to brace a damaged wall to prevent failure in the future.

The process is straightforward: After the wall is excavated and pushed back to plumb, exterior faces in the fourth course from the top are removed at 4-ft. intervals along the length of the wall. The bottom block below the top opening is also opened, and steel rebar is worked up and down inside the core to clear mortar flash at the joints. Debris can be removed from the opening in the bottom block.

With the block cores cleared of obstructions, steel rebar is placed in the cores. The rebar projects out of the block at the top opening perpendicular to the

wall, where it intersects a reinforced-concrete grade beam running parallel to the wall. The cores are then filled with concrete after which the foundation wall can be tuck-pointed and waterproofed, and new drain tile can be added.

Crushed stone is then added to within 6 in. of the projecting rebar. Then the 12-in. high concrete grade beam is formed on top of the stone fill, sloped away from the foundation wall. (The width of the beam can be determined by an engineer but is never less than 12 in.) Soil fill can be placed over the beam to restore the surface to its original condition.
